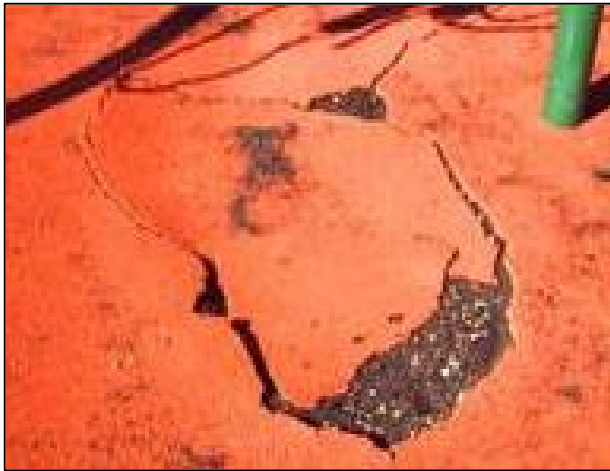
When there is too much cracking and extensive repair, it is more cost effective to remove the loose rubber, patch, and install a new wear course. In most cases, a small layer of cushion material is required to provide a smoother, more stable surface for the new wear course.

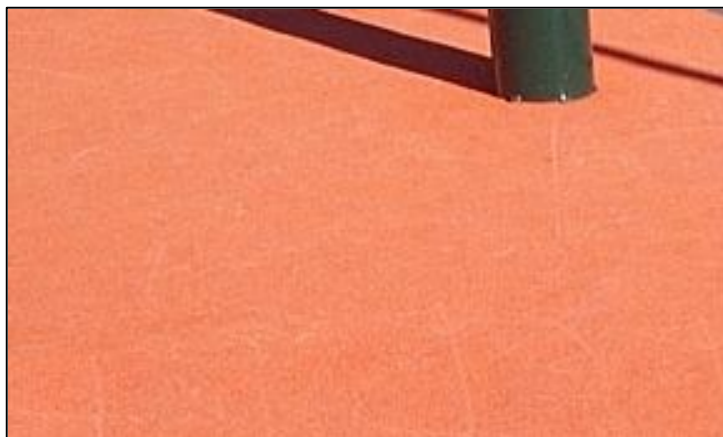
After the damaged areas were removed and new rubber was installed this surface looks new again.
